NASA Technical Paper 2153

# Buckling and Failure Characteristics of Graphite-Polyimide Shear Panels

Mark J. Shuart and Jane A. Hagaman

Mark J. Shuart and Jane A. Hagaman Langley Research Center Hampton, Virginia

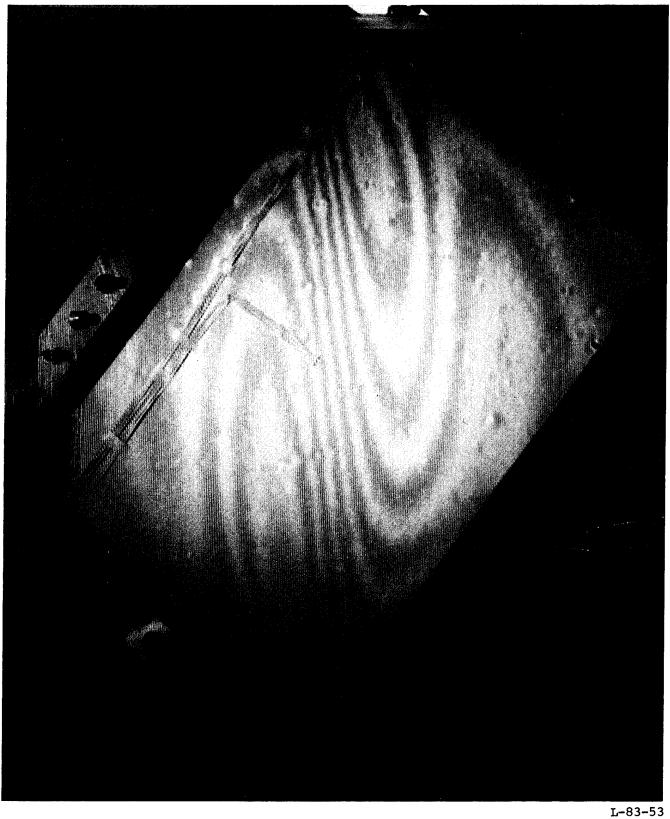
For tests at room temperature, the moiré-fringe technique was used to monitor out-of-plane deflections. A typical moiré-fringe pattern of the skin buckling mode

prior to failure is shown in figure 5. The moiré-fringe technique was not used for the elevated temperature tests.

buckling mode (fig. 7), which agrees with experiment as shown in figure 5 (the buckling mode shape did not change during the test). The analysis predicted a bladerolling mode for the blade-stiffened panel and a local or short wavelength buckling mode in the unstiffened region (fig. 8) between the reinforcements and the start of the stiffened skin for the hat-stiffened panel.

Figure 5.- Moiré-fringe pattern of unstiffened skin buckling mode prior to failure.

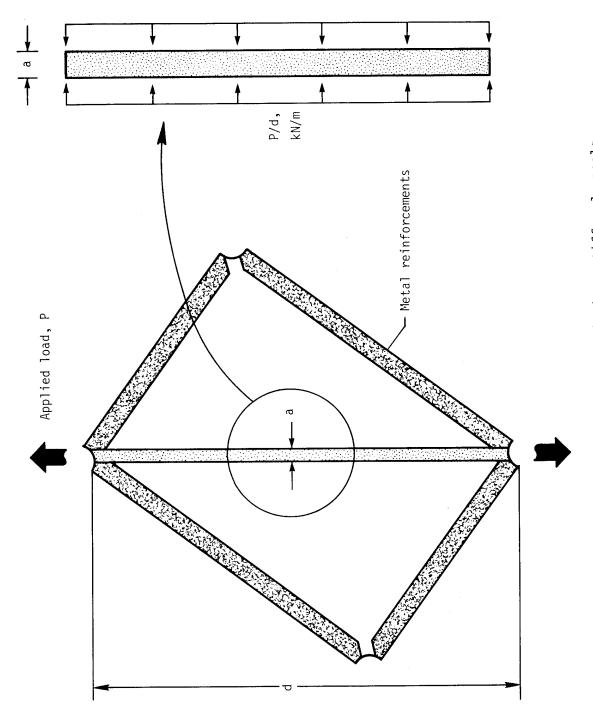
The mechanism of failure of the unstiffened panels was a fixture-initiated instability and is illustrated in figure 12. Because of specimen geometry and loading, a strip in the specimen center was equivalently loaded in compression. Failure occurred when this strip buckled because of the inplane compressive loading. For the room-temperature tests, the calculated buckling load for this strip (ref. 7) was within the scatter of the specimen failure loads. Failed unstiffened test specimens are shown in figure 13. Figure 13(a) shows a failure in the specimen corner at the reinforcement-skin interface which is a region of severe stress concentrations. Figure 13(b) shows a similar failure for a specimen tested at 316°C. The failure data obtained at 316°C were lower than those obtained at room temperature (table 3). This difference in failure results may be because of the different adhesives used for specimen fabrication. The reinforcements disbonded from the skin at elevated temperature (fig. 13(b)) which increased the width of the strip in compression. An increase in strip width of 10 to 20 mm (depending on the degree of disbonding) would result in strip buckling loads within the scatter of the failure loads for specimens tested at 316°C.

Figure 12.- Compression-loaded strip in unstiffened panels.

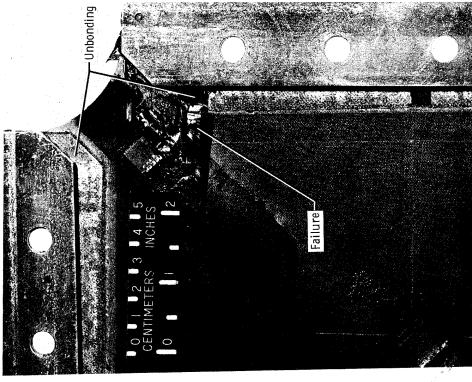
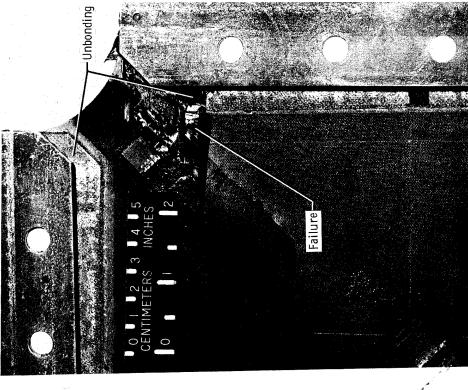
(a) Specimen tested at room temperature.

(b) Specimen tested at 316°C.

Figure 13.- Failed unstiffened panels.

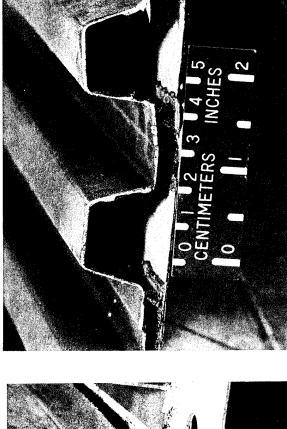
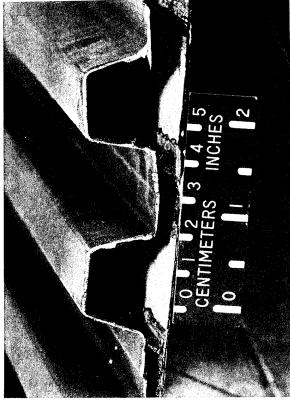
The failure mechanism for the stiffened panels is shown in figure 14. As a result of the buckling modes, significant inplane and out-of-plane stresses caused the stiffeners to disbond as illustrated in figure 14(b). This failure mechanism was independent of test temperature. Again, the differences between the stiffened panel data obtained at room temperature and at 316°C may be due to the different adhesives used.

(a) Failed panels.

(b) Close-up view of disbonded regions.
